Seismic Imaging as a Means to Investigate Abandoned Underground Mines

A geophysical investigation was conducted to investigate subsidence along a highway in southeastern Kansas. A portion of the first 6,000 feet of US Highway 69 after it crosses from Oklahoma into Kansas is known to overlie abandoned, underground lead and zinc mines. These mines were active in the first half of the 20th century. It was not known if available mine maps were accurate. Since the 1940's, there have been several surface subsidence incidents near the highway believed to be related to the abandoned mine openings. NSA applied its **RockVision3D™** seismic tomographic imaging system to image two vertical profiles of the ground under US Highway 69. These profiles helped the Kansas Department of Transportation assess the condition of these abandoned mine workings and to determine if some strategy was required to mitigate any possible risks.

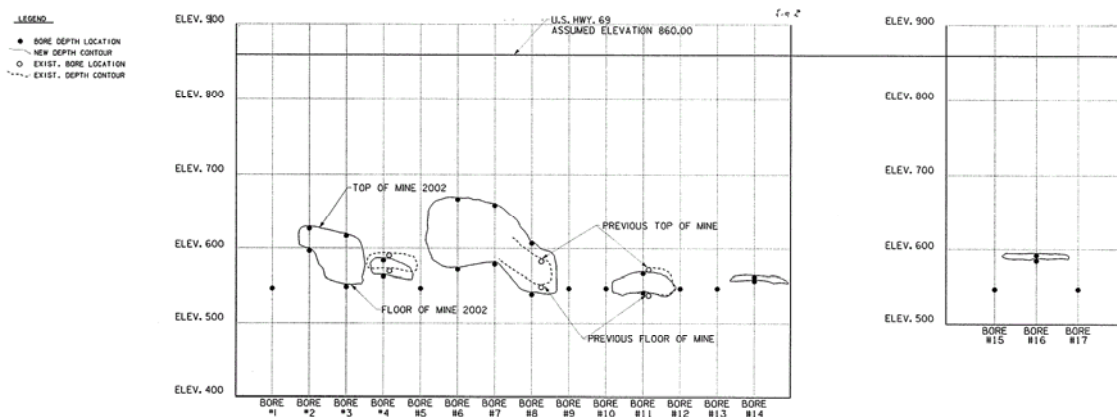
Figure 2. Vertical profile of voids encountered.

Some ground information for the Hwy. 69 project within the survey area was known from the borehole data. This included ground type and quality along the borehole length and where the boreholes encountered voids or mine openings (see Figure 2). This information is shown next to each of the boreholes used for each tomographic figure, but was not used as input data into NSA's RockVision3DTM software prior to generating the tomographic images. The tomographic images included in this report were generated using only the raw seismic data as input.

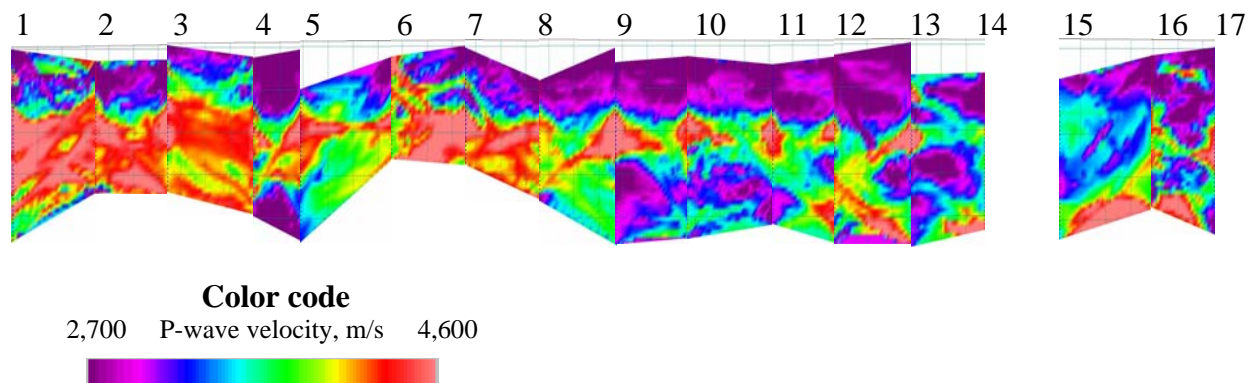
Figure 3. Composite image of panels resulting from seismic surveys.

A tomographic, seismic velocity ground image was produced for each adjacent pair of boreholes resulting in the 15 two-dimensional images, shown as a composite image in Figure 3. Limestone of varying degrees of competence exists throughout the panels, usually of significant thickness (20 m to 50 m). The images were evaluated for indications of (1) any mine voids in addition to those indicated in the available mine maps, (2) mine roof failures migrating toward the surface, and (3) the thickness of competent rock between the top of the mine voids and the surface to evaluate the probability of near-term failures to the surface. Regardless of their origin (natural or mining-related), the potential of any voids detected to impact the final design should be evaluated.

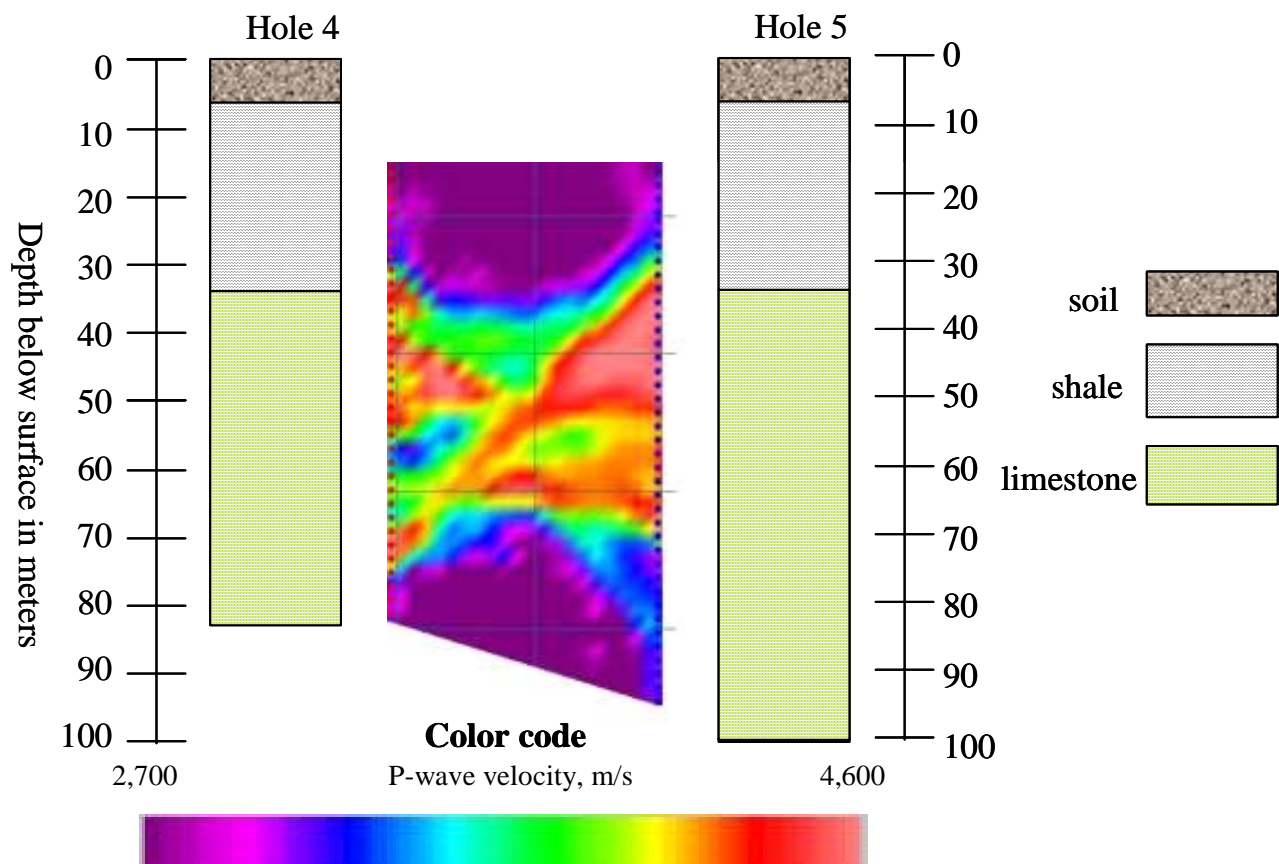
Figure 4. Panel 4-5 with borehole geologic profiles.

Panel 4-5 (Figure 4) indicates the presence of approximately 25 m of competent limestone beneath the shale, but a large void, likely caused by mine roof failure migrating toward the surface is present.

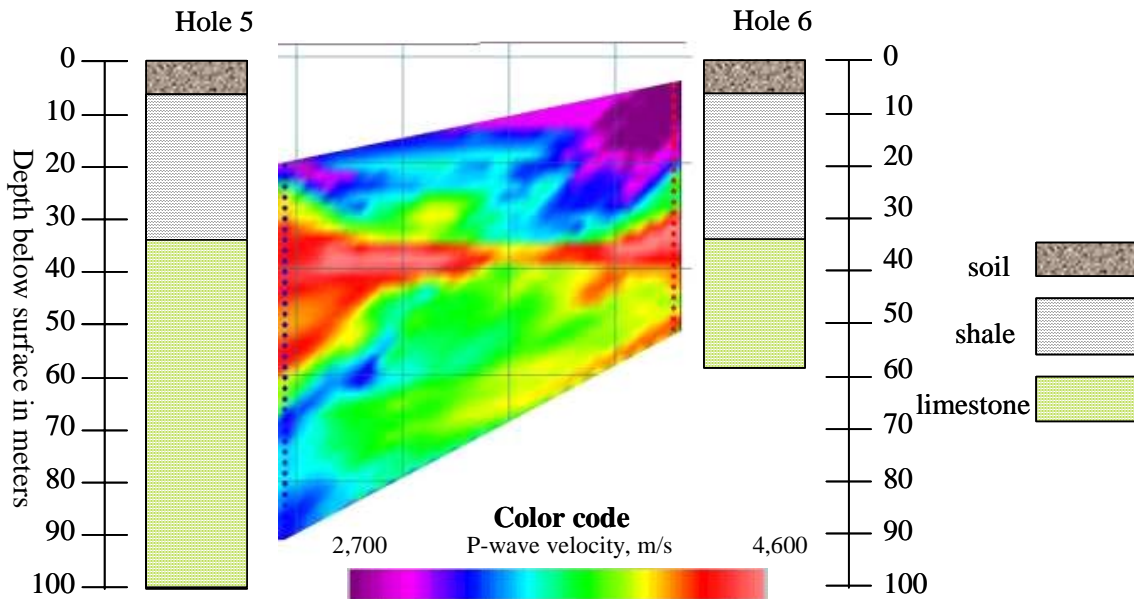
Figure 5. Panel 5-6 with borehole geologic profiles.

Panel 5-6 (Figure 5) shows that only a thin (approximately 5-m) layer of competent limestone exists between the mine roof and the shale. The remaining limestone appears to be less competent. There is no indication that roof failure has migrated up through this weaker

limestone layer, but the potential for roof failure migration is likely higher in this area because of the reduced limestone competence.

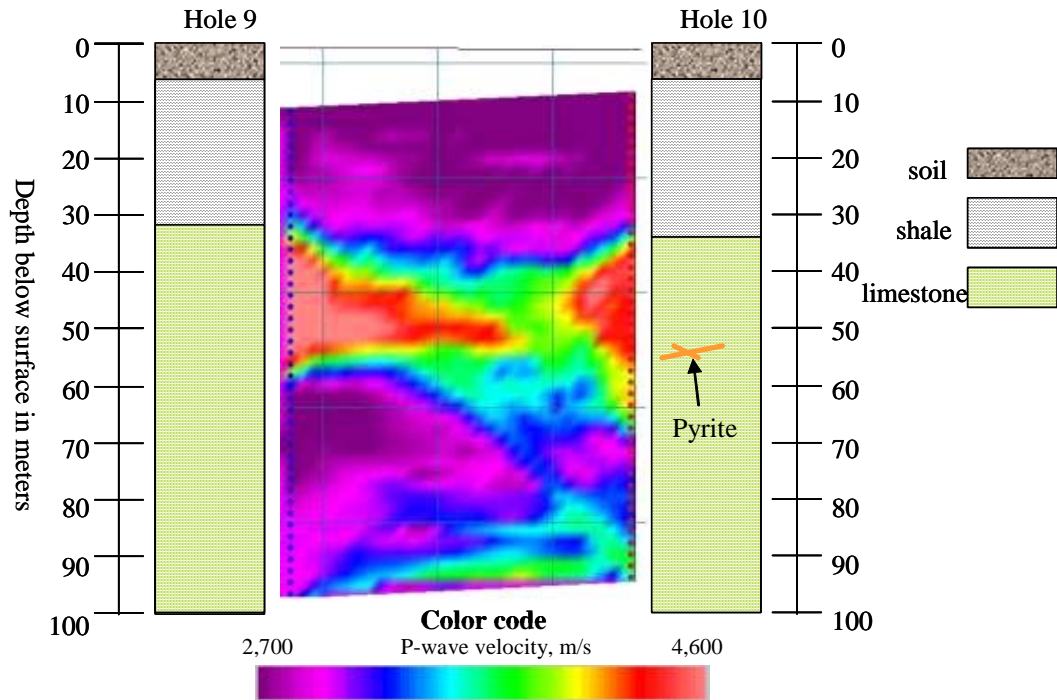
Figure 6. Panel 9-10 with borehole geologic profiles.

Panel 9-10 (Figure 6) indicates a large void between Boring #9 and Boring #10, closer to Boring #9. The drill log indicated water in this area, but no indication of a mine void. This could possibly be a breccia zone. About 20 m of competent limestone separates the void and the shale.

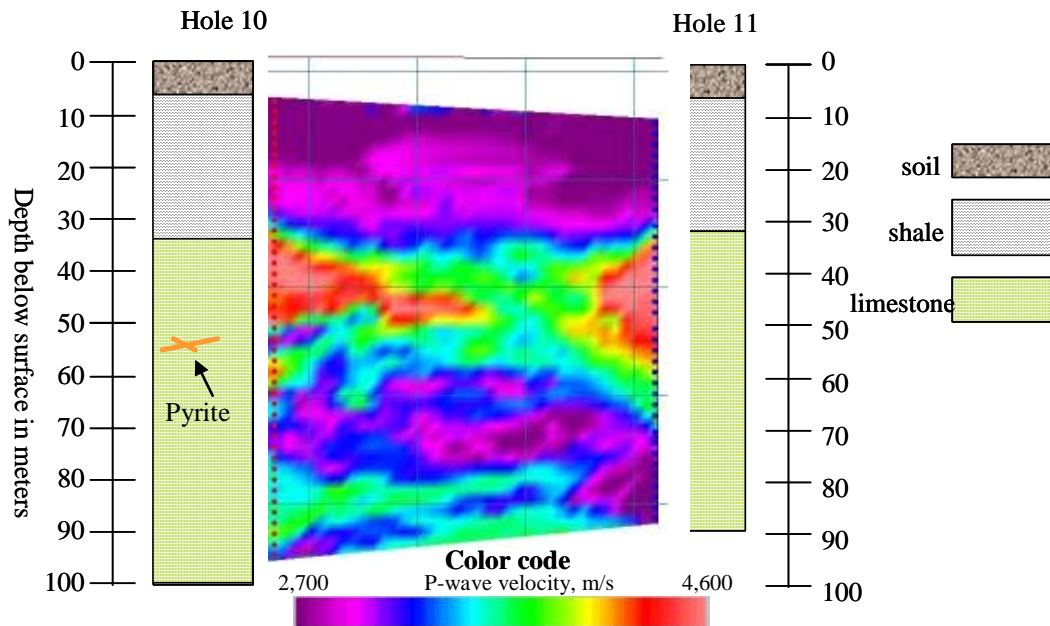
Figure 7. Panel 10-11 with borehole geologic profiles.

Panel 10-11 (Figure 7) indicates the presence of approximately 20 m of competent limestone beneath the shale. Beneath this competent zone, about 30 m of less competent limestone is indicated. This less-competent zone appears to be brecciated or otherwise weakened, although the possibility of migrating roof failure cannot be ruled out.

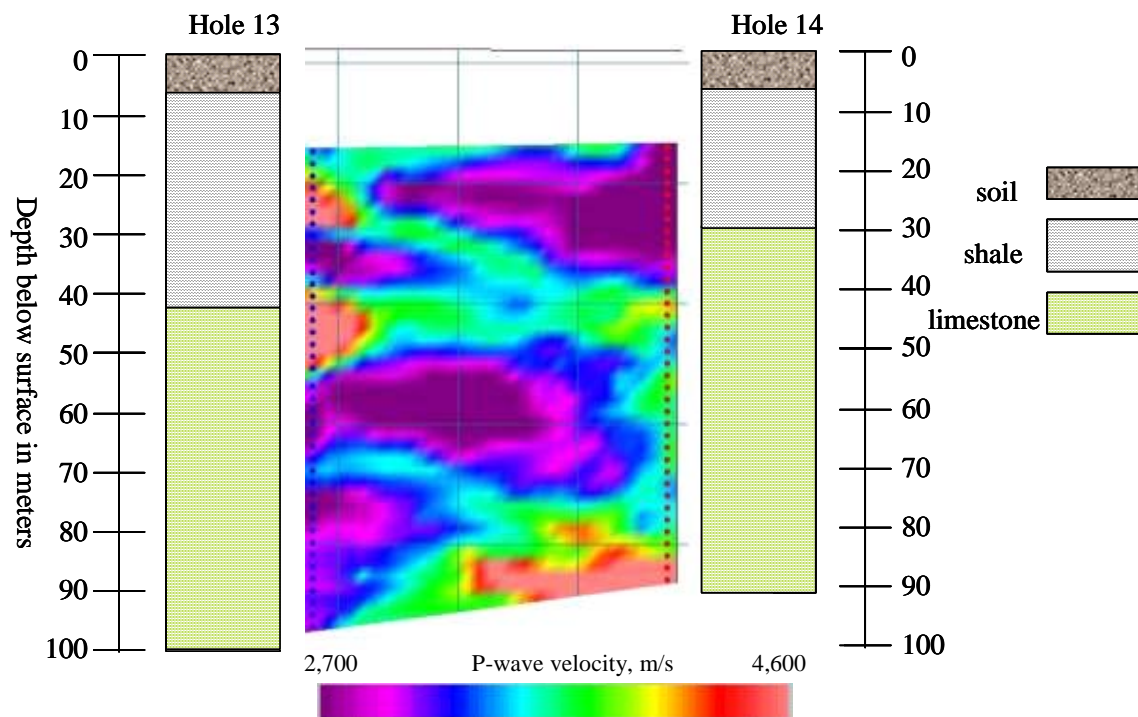
Figure 8. Panel 13-14 with borehole geologic profiles.

Panel 13-14 (Figure 8), shows that apparent voids exist between Borings #13 and #14, closer to Boring #13. Because of their location, it is surmised that these voids are naturally occurring rather than mining-related.

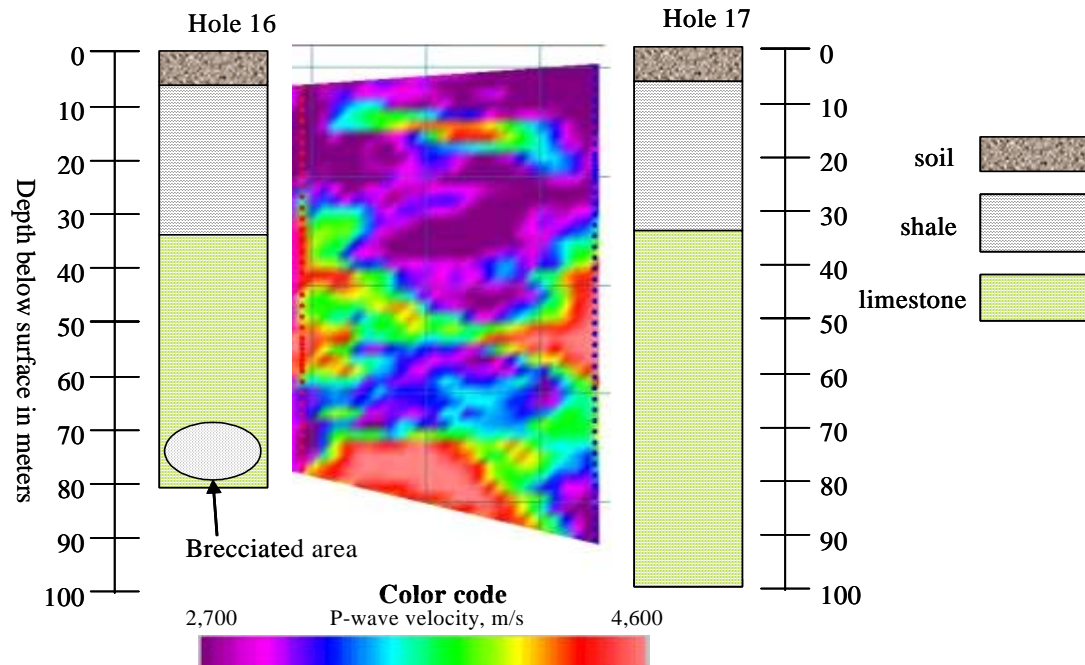
Figure 9. Panel 16-17 with borehole geologic profiles.

Panel 16-17 (Figure 9) indicates the presence of approximately 10 m of competent limestone above the mine roof; the remainder of limestone (approximately 40 m) shows areas of voids/weakness/ brecciation.
